Manhole Inspection Summary

Manhole # S19C1_009MH

Insp Date: **11/17/08 10:50 AM**

Location Address: **1952 sponson st**

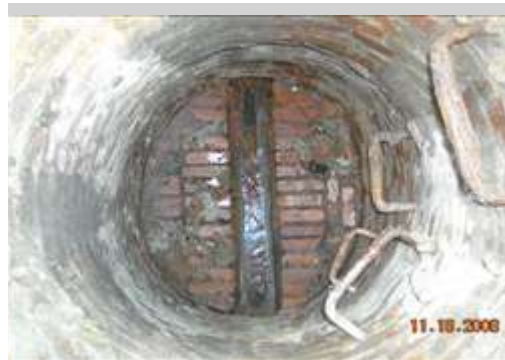
Top View

Cover Shape: **Circular** Diameter: **24** (in.) Length: **0** (in.) Dist A/B Grade: **0** (in.)

Type: **Sanitary** Condition: **Sound** Cover Material: **Cast Iron**

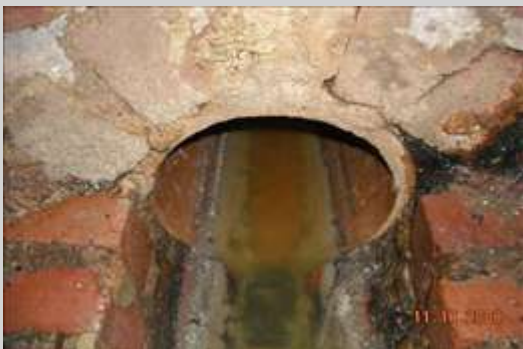
6 O'Clock Inflow

8 in. Circular Gravity Sewer
Pipe In @ 6 O'Clock

Pipe Height: **8.4** (in.) Rod and Bar (Angled)
Pipe Material: **Clay** ☐ Pipe Lined
Invert Depth: **7.90** (ft.) Flow Characteristics: **Slow**
Deposits: ☒ None ☐ Mud ☐ Sludge ☐ Debris ☐ Grease
Silt Depth: **0** (in.) Deposits Extent:
Infiltration: **None** Pipe Seal Cond: **Sound**
